Drinking Water Audit Report

Local Authority:	Wexford County Council	Date of Audit:	29 th May 2012	
Plant visited:	Castlemoyle WTP (3300PUB1589)	Date of issue of Audit Report:	11 th June 2012	
		File Reference:	DW2012/65	
		Auditors:	Mr Nigel Hayes Ms Yvonne Doris	
Audit Criteria:	 The European Communities (Drinking Water) (No. 2) Regulations, 2007. The EPA Handbook on the Implementation of the Regulations for Water Services Authorities for Public Water Supplies (ISBN: 978-1-84095-349-7) The recommendations specified in the EPA Report on The Provision and Quality of Drinking Water in Ireland. The recommendations in any previous audit reports.

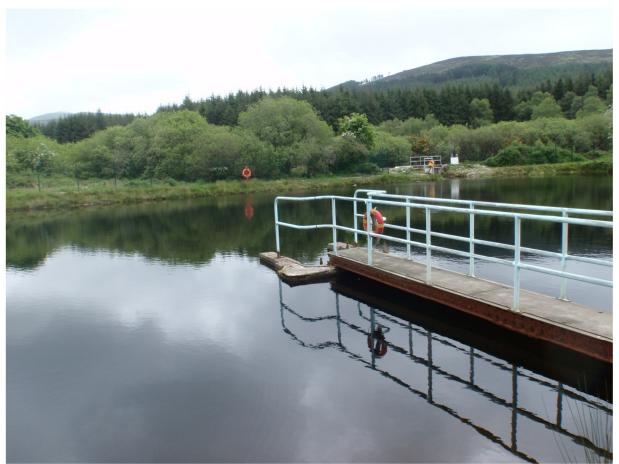
Photograph 1: Dranagh impoundment

1.	otection	
	a. Dranagh source		Dranagh source
			i. The source originates from an upland spring.
ii. Forestry is the predominant feature of land use in the catchmer		ii. Forestry is the predominant feature of land use in the catchment.	
iii. Source protection works, including the erection of fence			iii. Source protection works, including the erection of fencing, were carried out at the
			Dranagh impoundment approximately four months ago (see Photograph 1).
			iv. Online monitors measure ammonia, pH and turbidity of the source water.

1. The Water Services Authority should ensure that the source protection and catchment risk assessment score for the *Cryptosporidium* risk assessment is urgently reviewed in detail and appropriate measures implemented to reduce the risk.

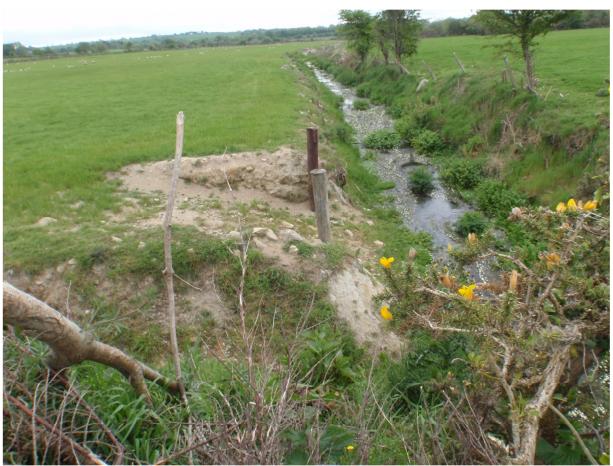
Photograph 2: Possible Animal Access Point in Poulmounty Tributary

v. The Dranagh impoundment is inspected on a daily basis by water services personnel.
		b. Poulmounty source	
			i. Agriculture is a predominant feature of land use in the catchment.
			ii. The Council advised that the source is supplemented by numerous tributaries. One
			of these tributaries appeared to have an animal access point (see Photograph 2).

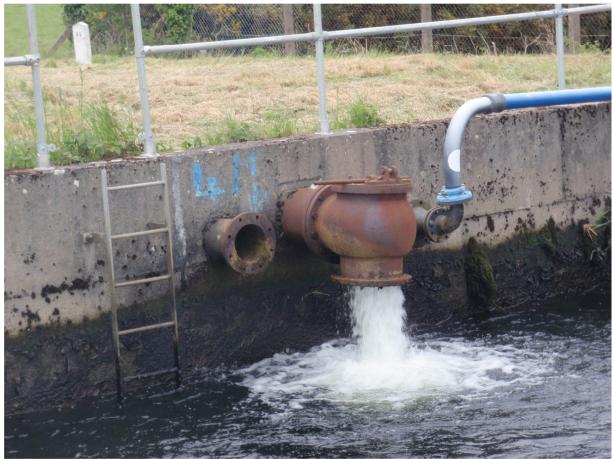
Photograph 3: Poulmounty source water entering the Ballyleigh Balancing Tank

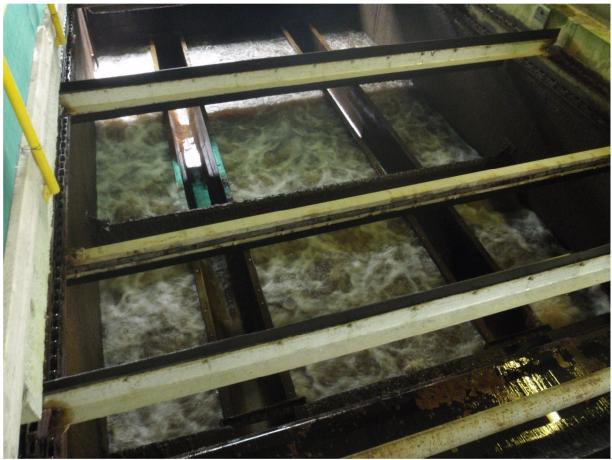
Photograph 4: Filter backwash at the Castlemoyle Plant

- i. DAF coagulation is currently being bypassed at the plant as the low turbidity levels of the raw water do not allow the effective formation of floc.
- ii. The filter backwash was uneven throughout the filter. Large boils were observed in some parts of the filter and dead areas were observed in others.
- iii. The filter is brought back into operation after approximately 15 minutes. There is no turbidity monitor on the outlet of the filter to determine the turbidity levels of the post backwash filtrate.

f.	backwashed on a daily basis. The backwash carried out on the day of the audit was uneven throughout the filter (see Photograph 4) and large boils were observed in some parts of the filter and dead areas were observed in others. The filter is brought back into operation after a slow start of approximately 15 minutes. The Council stated that they cannot extend the slow start time due to supply demand.

- 5. The Water Services Authority should investigate the cause of the boils in the filter media and should take appropriate action to optimise the operation of the filter.

- 6. The Water Services Authority should ensure that the air/water backwash is even across the filter and should ensure that air nozzles are fully functional and not blocked or damaged.

- 7. The Water Services Authority should review the operation and condition of the sand filter and ensure that any of the abnormal operating conditions (as outlined on pages 43 to 45 of the EPA publication "*Water Treatment Manual on Filtration*") are urgently rectified.
